# Manhole Inspection Summary

Manhole # S61K\_\_022MH

Insp Date: **3/21/08 10:21 AM**

**Location** Address: **830 Rappolla St.**

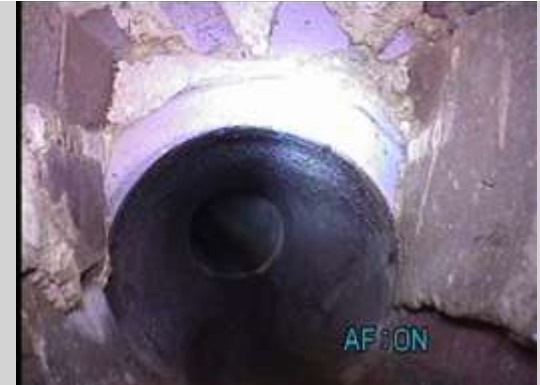
12 O'Clock Outflow

8 in. Circular Gravity Sewer  
Pipe Out @ 12 O'Clock

Pipe Height: **8.4** (in.) Rod and Bar (Angled)  
Pipe Material: **Clay** ☐ Pipe Lined  
Invert Depth: **8.08** (ft.) Flow Characteristics: **Fast**  
Deposits: ☒ None ☐ Mud ☐ Sludge ☐ Debris ☐ Grease  
Silt Depth: (in.) Deposits Extent:  
Infiltration: **None** Pipe Seal Cond: **Sound**

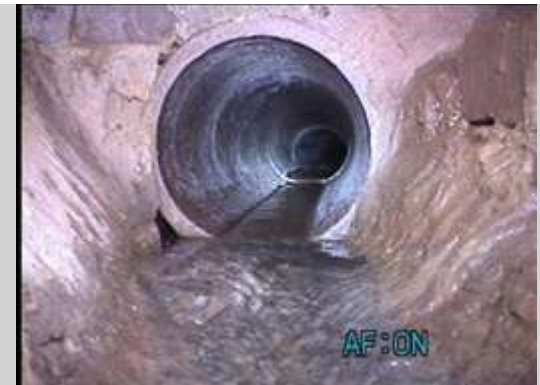
6 O'Clock Inflow

8 in. Circular Gravity Sewer  
Pipe In @ 6 O'Clock

Pipe Height: **8.4** (in.) Rod and Bar (Angled)  
Pipe Material: **Clay** ☐ Pipe Lined  
Invert Depth: **7.67** (ft.) Flow Characteristics: **Fast**  
Deposits: ☒ None ☐ Mud ☐ Sludge ☐ Debris ☐ Grease  
Silt Depth: (in.) Deposits Extent:  
Infiltration: **None** Pipe Seal Cond: **Sound**
